# Fireplaces, Flues and Chimneys

SPAB Technical Advice Note

Marianne Sühr MRICS, SPAB Lethaby Scholar and  
Sally Stradling BSc (Hons), MA, IHBC, FSA

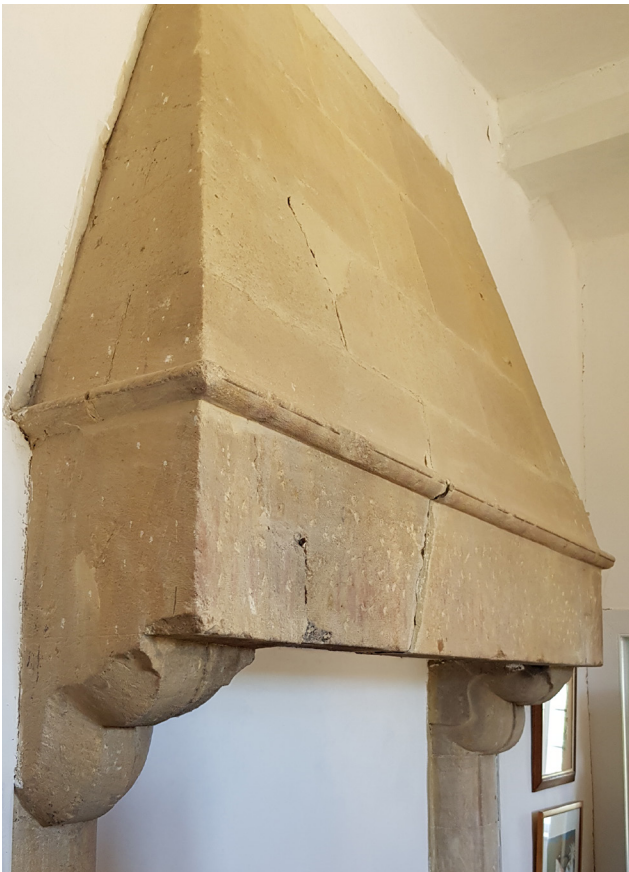
**Figure 3:** Corbelled stone hood, c1315. Gatehouse, Ham Court, Bampton, Oxfordshire.

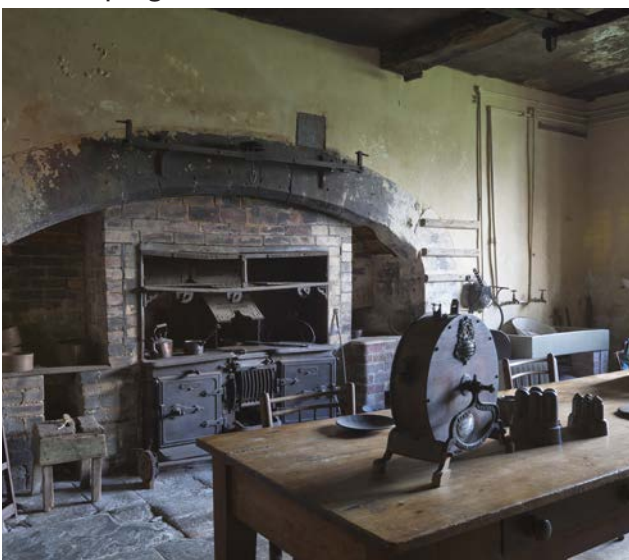
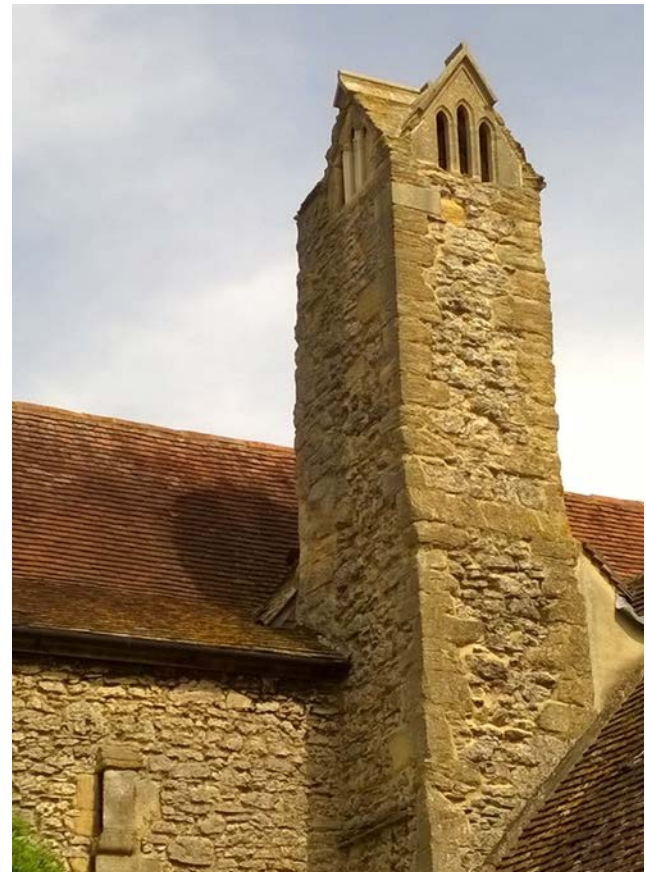
**Figure 4:** Flue with triplets of lancets, c1260. The Checker, Abingdon Abbey,

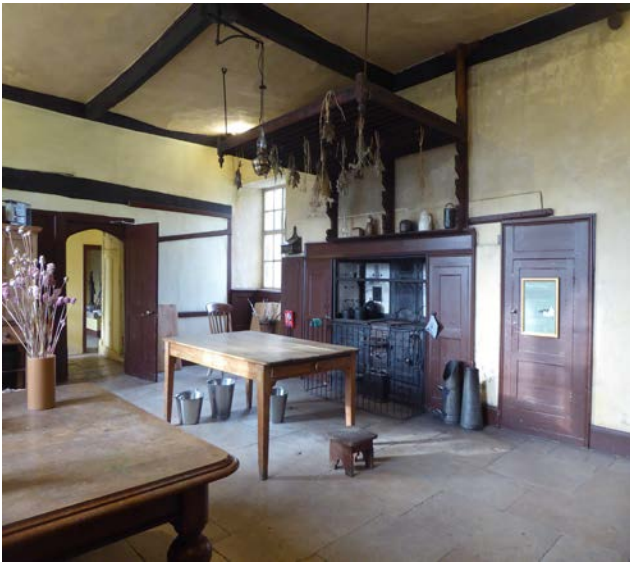
**Figure 6:** Kitchen, c1300-1900s. Manor Farm, Cogges, Oxfordshire. Open hall with inserted floor, lateral chimney stack with wide fireplace, later inserted cooking range and side cupboards. Note the spit rack above the fireplace. Photo: © Heather Horner, with thanks to Cogges Heritage Trust

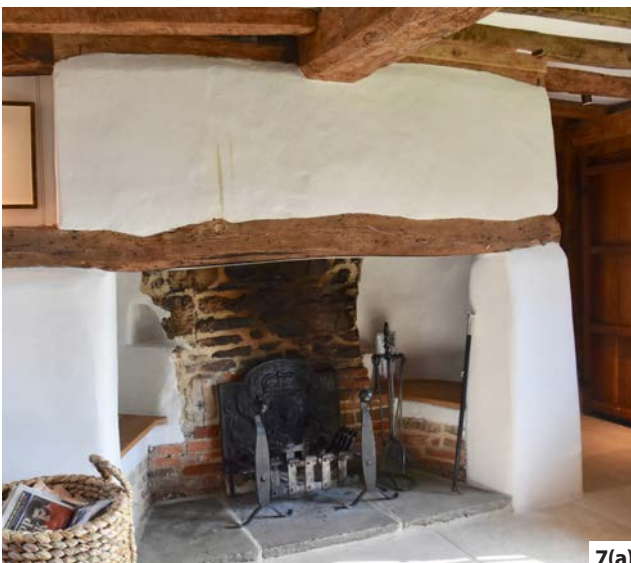
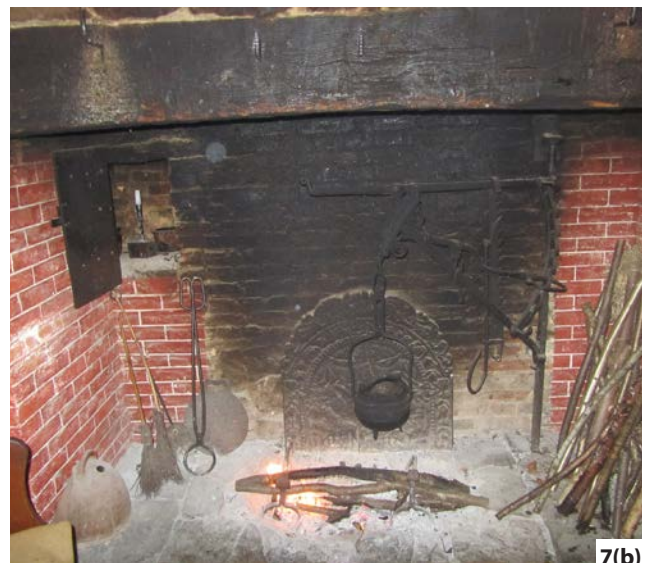
**Figure 7:** Inglenook fireplaces: (a) South Oxfordshire, c1600s, with seat alcoves either side for enjoying the warmth of the fire. The original flagstones under the grate would have been flush with the floor to allow debris to be swept into the hearth. (b) Kitchen fireplace, c1550, with pot crane, bread oven and cast iron fireback. Pendeon, Weald and Downland Living Museum, West Sussex.

The 'inglenook' fireplace in the now combined hall/kitchen became widespread, superseding the open hearth in vernacular cottages and farmhouses of 16th- and 17th-century date (see figure 7). This enclosed the fire on three sides and provided the opportunity for seats to warm occupants. There was perhaps the opening to a bread oven (without flue) at one side and salt cupboards, or a ham or bacon curing chamber, on the other. Cooking pots were suspended from iron hooks and pans supported on iron grates over the embers. The hearth was flush with the rest of the floor to allow dirt from the room to be swept into it. The parlour became heated by a separate walled fireplace. Back kitchens/service rooms came into being for the separation of tasks such as baking, brewing and washing clothes (see figure 8).<sup>16</sup>

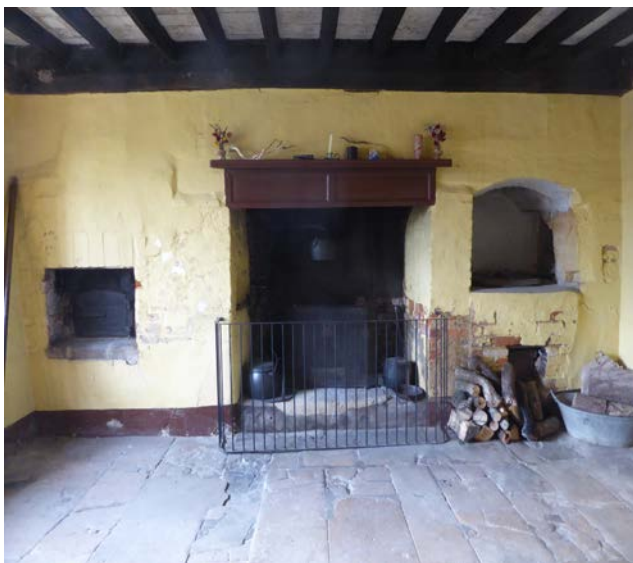
**Figure 8:** 'Back kitchen', c1600s-1900s. Manor Farm, Cogges, Oxfordshire. Main range in centre, bread oven to left, copper for washing clothes to right. Photo: © Heather Horner, with thanks to Cogges Heritage Trust

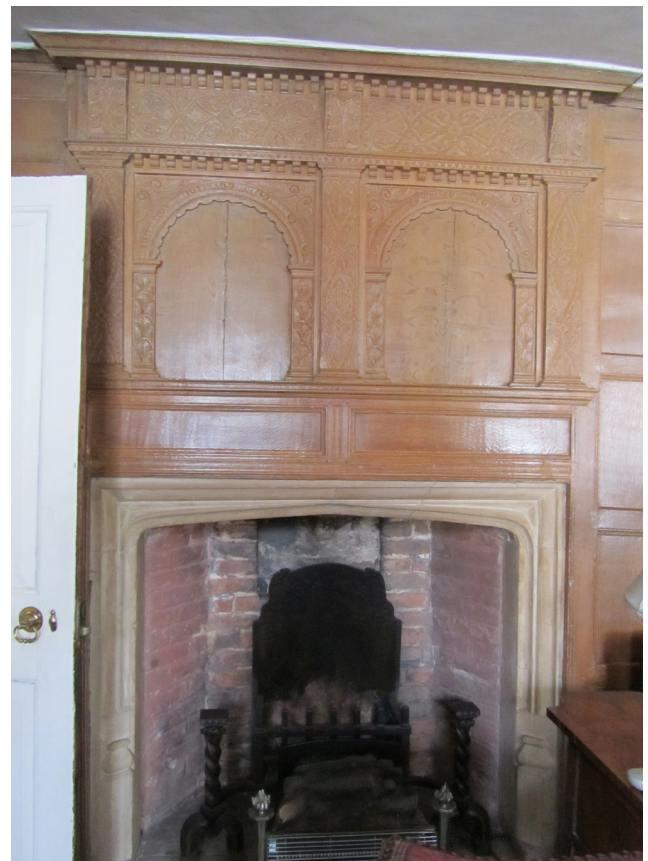
**Figure 9:** Renaissance details, early 17th century. Abingdon, Oxfordshire. Photo: Sally Stradling

In larger houses, arched stone or brick fireplaces frequently became principal architectural features in the 16th and 17th centuries. Common are four-centred 'Tudor' arches, sometimes with decorated spandrels, moulded jambs and a moulded mantel shelf. Lesser buildings are more likely to have simple timber lintels of oak or elm, sometimes with chamfer stops, on stone or brick jambs. In the early 17th century, elaborate stone, plaster or timber overmantels were used to display Renaissance fashions imported by craftsmen from Italy, Flanders and Germany and interpreted by local craftsmen (see figure 9).

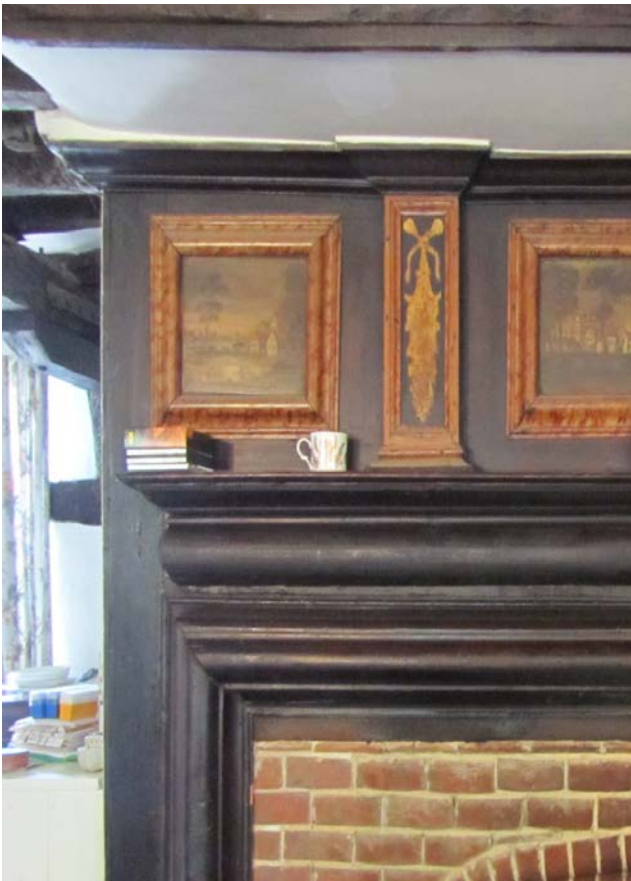
**Figure 10:** Detail, fireplace with bolection moulding, c1700s. Steventon, Oxfordshire. Photo: Sally Stradling

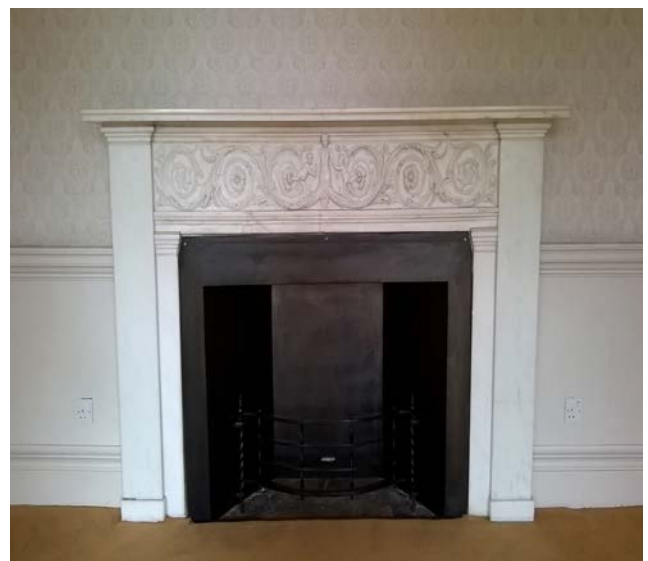
**Figure 11:** Fireplace, 1750s. Nuneham Park, Oxfordshire. Photo: Sally Stradling, with thanks to Global Retreat Centre

Early 18th-century fireplace designs were often heavy and ornate with swags, scrolls, masks and shells – the latter a signature motif of designer William Kent. Materials included stone, marble, wood or scagliola. Later in the century and under the influence of Robert Adam, lighter neoclassical designs appeared with motifs such as urns, swags and figures from classical mythology (see figure 11).

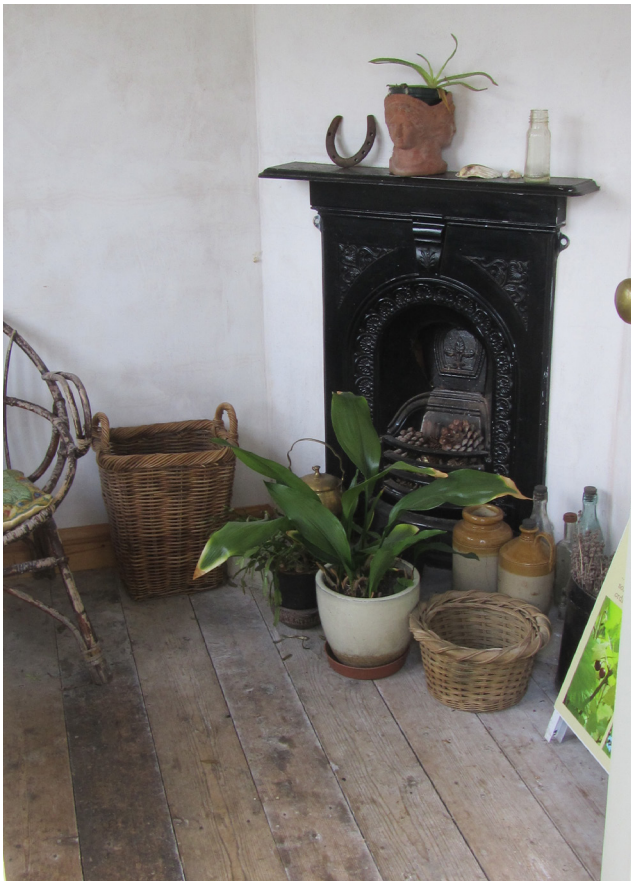
**Figure 12:** Mass-produced fireplace, c1875. Warwick.  
Photo: Sally Stradling

Foundries, such as those of the Carron Company and at Coalbrookdale, mass-produced cast iron fire surrounds, sometimes with integral grates (see figure 12). Timber and plaster surrounds tended to be painted, and cast iron painted or blackleaded. A hierarchy of materials and decoration evolved for public and private rooms with greatest expense being lavished on the most frequented sitting rooms, while family bedrooms and attic rooms were provided with plain fireplaces, commonly of painted timber or cast iron.

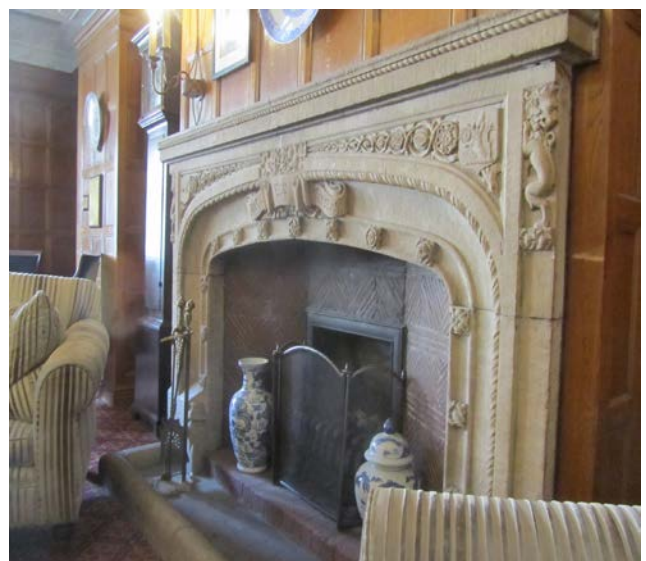
**Figure 13:** Tudor revival fireplace, late 19th century. Randolph Hotel, Oxford.  
Photo: Sally Stradling

With the 'battle of the styles', a multitude of revival chimneys and associated fireplaces were produced during the 19th century from neo-Gothic, Elizabethan, early Renaissance revival to the Queen Anne style of Norman Shaw, W E Nesfield and others (see figure 13).

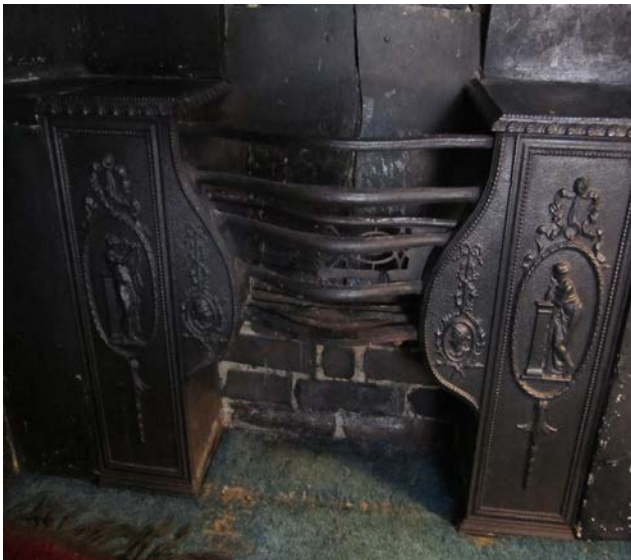
**Figure 14:** Eighteenth-century hob grate. Abingdon, Oxfordshire.

grate with the fire raised over the hearth and fenders to protect against flying embers (see figure 14). These were manufactured in great numbers by the Carron Company and Coalbrookdale foundries.

The hob grate, unlike its freestanding predecessors, was set into the fireplace and had horizontal bars to hold the burning coal in place. Flat metal plates were located on either side on which pans and kettles could be heated. In practice, very little heat was reflected out into the room and the wide fireplace opening made it difficult to control draughts or prevent smoking. Numerous experiments and ideas for the control of noxious smoke came and went from the 17th century onwards. Many books contained advice on the subject.<sup>18</sup>

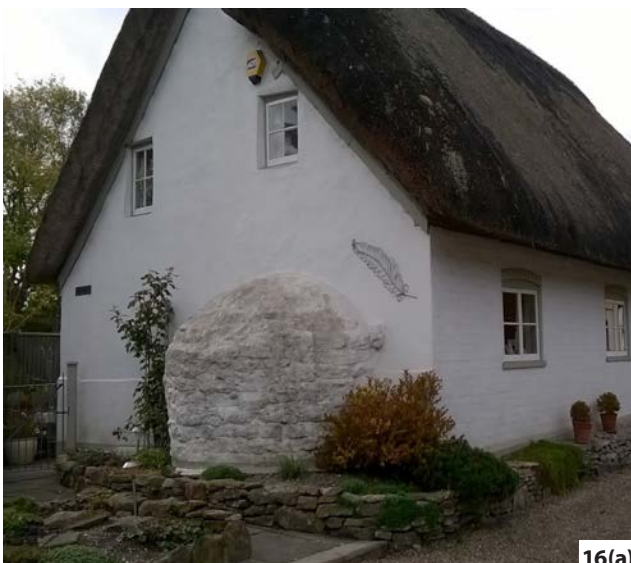
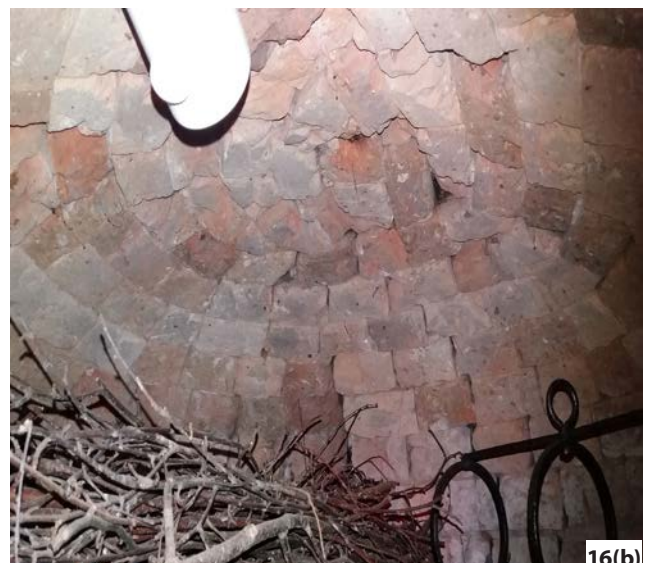
**Figure 16:** Bread ovens: (a) Bread oven 'bulge'. East Hanney, Oxfordshire. (b) Interior of bread oven showing brick lining. Old Priest's House, West Hoathly, West Sussex  
Photos: Sally Stradling (a) and Matthew Slocombe (b)

Bread ovens may survive intact in wide inglenook fireplaces which have been blocked when smaller fireplaces were inserted within them. Regional variations abound – bread ovens were commonly built into the side or back of fireplaces either as original features or later additions. Sometimes they comprised domed or roofed external additions (see figure 16). These ovens did not have their own flues. They relied on being heated by embers transferred from the main hearth or wood furze burned and the embers raked out once the structure of the oven was sufficiently warmed. The bread dough was then introduced to cook.

Many stone ovens decayed through successive heating so have been re-lined in brick. Doors were made of large stone slabs in areas of hard stone, such as granite in Weardale, and held in position by a loop of iron either side of the opening. Elsewhere thick elm doors, with a large vertical central handle to lift them into position, have been found, for example, in Wiltshire and Gloucestershire. Doors could be smeared with clay or dough to seal the oven. By the 19th century these were superseded by cast iron doors.

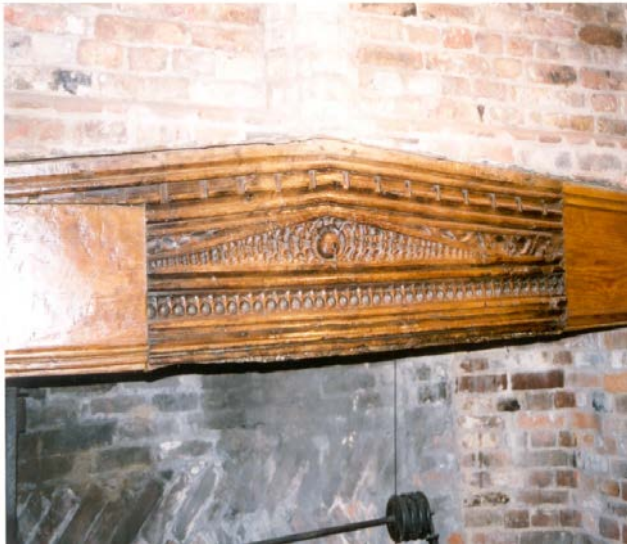
**Figure 17:** Repair is preferable to replacement, as with the repaired ends of this mantel beam. They respect the original but do not attempt to ape it. Photo: © Douglas D Kent

An abstemious approach should be adopted that prioritises repair *in situ* over wholesale removal and replacement, which is justified only where absolutely necessary (see figure 17). Such an approach includes keeping, wherever possible, any cranes, smoke jacks, hooks and items of chimney furniture, for example, grates, firebacks, firedogs and baskets that have historic associations with the building. It also places an emphasis on the retention *in situ* of ancient burn marks found on timber lintels and thought to be a deliberate, superstitious effort to protect the occupants and their possessions. Similarly items such as shoes, clothing or mummified cats, tucked away in chimneys to ward off evil spirits, should be retained in their original position (except where a fire hazard when they should be photographed and recorded *in situ* and then kept somewhere safely in the house).

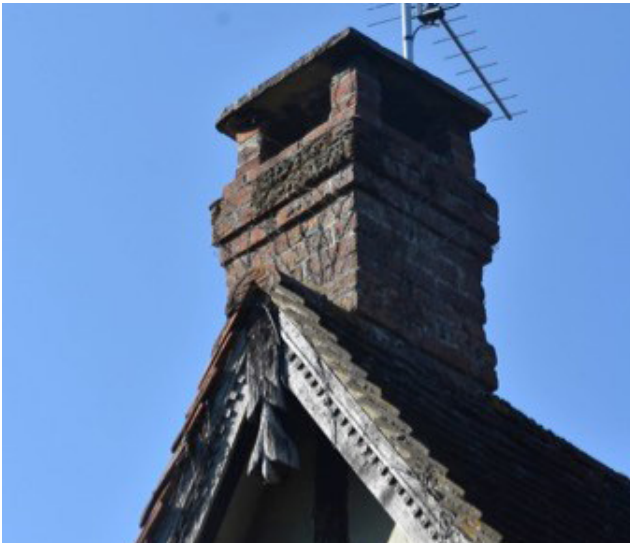
**Figure 21:** A 'dovecote' top can be used to protect large flue outlets from wind and rain, though is inadvisable on thatched buildings. A stone slab is placed above the flue opening raised on bricks at the corners. Such terminations should incorporate suitable bird mesh to stop nests being built under the slab. However, addition of a slab roof may affect the draw in certain situations. Always light a fire and check for unintended consequences before striking the scaffolding around the stack.

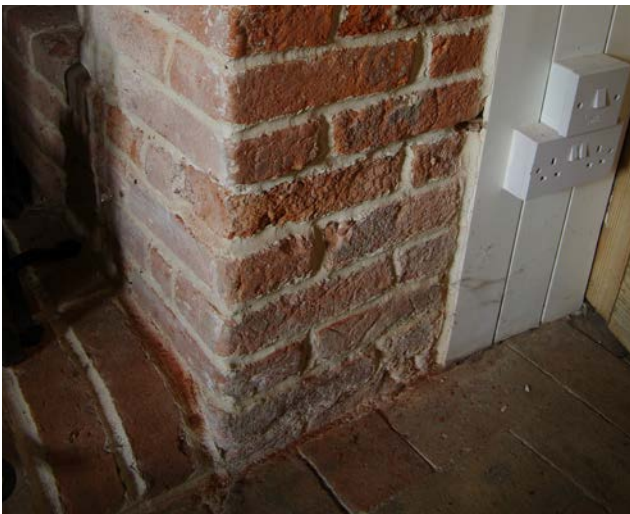
**Figure 22:** Spalling brickwork to inglenook fireplace due to aggressive cleaning.

The faces of bricks frequently become powdery (spall) after they have been subjected to aggressive cleaning, for example, sand blasting. Spalling can be difficult to stop but a 15-20% dilution of potassium silicate may be soaked into the face of the bricks to help densify them. Potassium silicate is moisture open and, as the binder is often used to make fire cement, is safe to use near heat. There is very little to no visible change to the colour or surface texture when using potassium silicate (see figure 22).

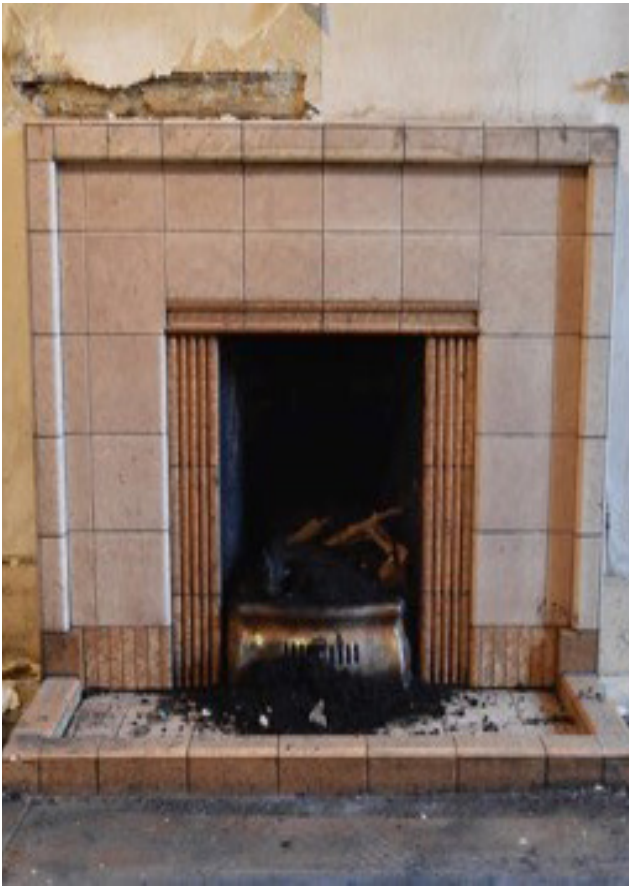
**Figure 23:** Later fireplace in earlier opening.  
Photo: Marianne Sühr

Additionally, consideration should be given to whether the masonry that blocks an earlier opening is forming a structural support (see figure 23). Before masonry is removed wholesale, a trial removal of one or two masonry units could help ascertain structural stability. This investigation, often in conjunction with a camera, can also assist with establishing the condition of the flue, lintel and support, as well as determining whether the removal of later inserted material could result in collapse of masonry above. Advice should be sought from a suitably experienced structural engineer where the integrity of a structure is in doubt.

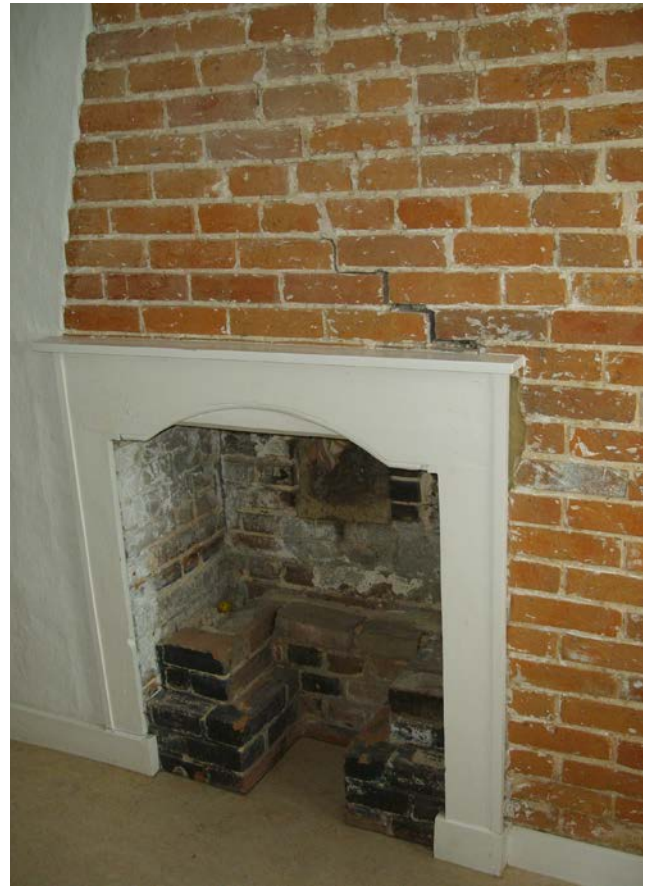
**Figure 24:** Cracking to chimney brickwork.  
Photo: © Douglas D Kent

It is not unusual to find wrought iron flat plates or angles built into brick fireplaces to support the masonry above. These often have surface corrosion, which can be the cause of very slight, localised jacking of the masonry (see figure 24). Thermal movements within the iron can be another cause of localised cracking, although their effects are usually not significant. It is often best to accept and tolerate such minor cracking.

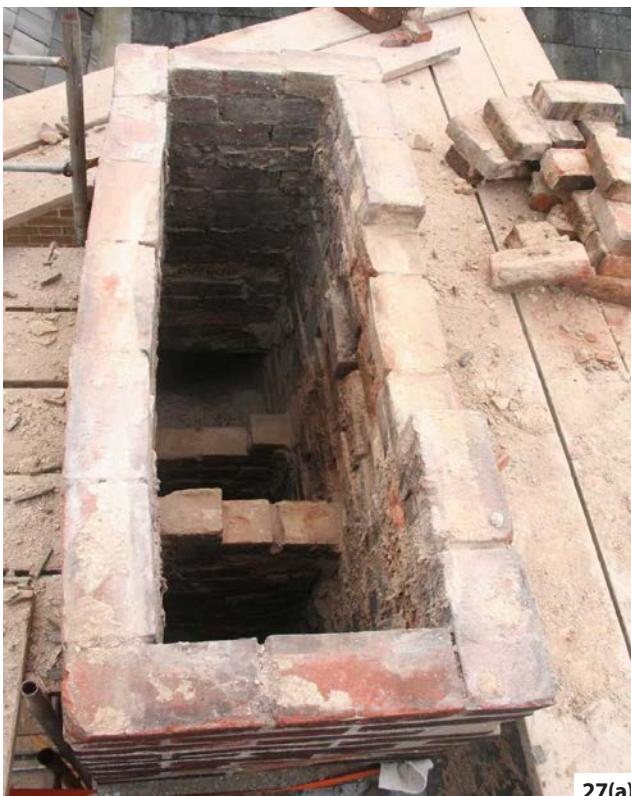
**Figure 27:** Withes: (a) Part-dismantled during repair. (b) After repair.

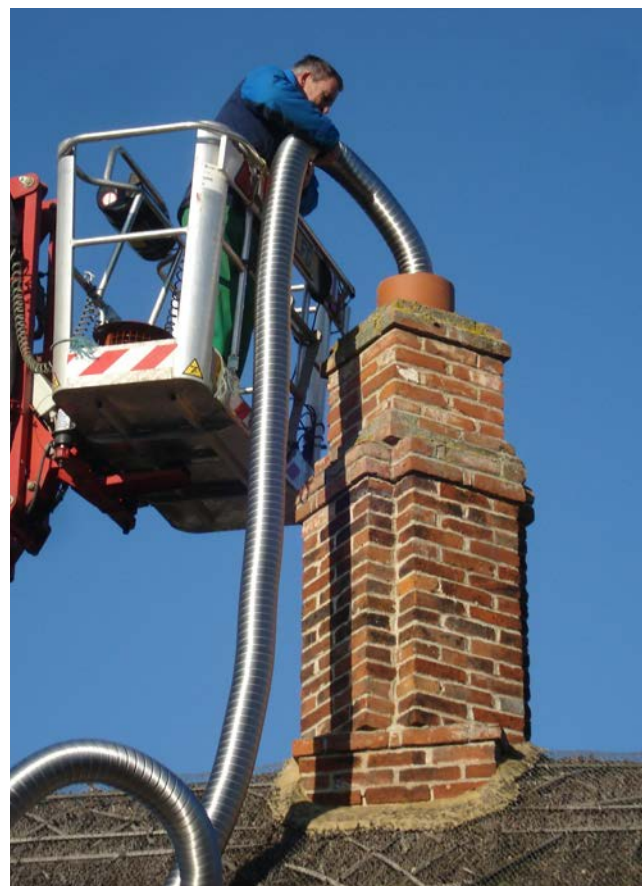
**Figure 29:** Flexible metal liner being inserted into chimney of thatched cottage to serve new gas stove after removal of a wood burner to reduce the fire risk.

It is advisable to insulate, or use pre-insulated, flexible liners to keep flue gases warmer, achieve a good updraught and reduce the likelihood of condensation with chimneys that are on outside walls or have tall stacks or wide flue diameters. Where the space around a lining is backfilled with loose-fill insulation, this should be breathable but not hydrophilic (moisture-absorbing), as well as incombustible. Foamed glass or expanded clay beads are ideal for this situation. They should not be mixed with mortar, otherwise eventual removal of the liner will be impeded.

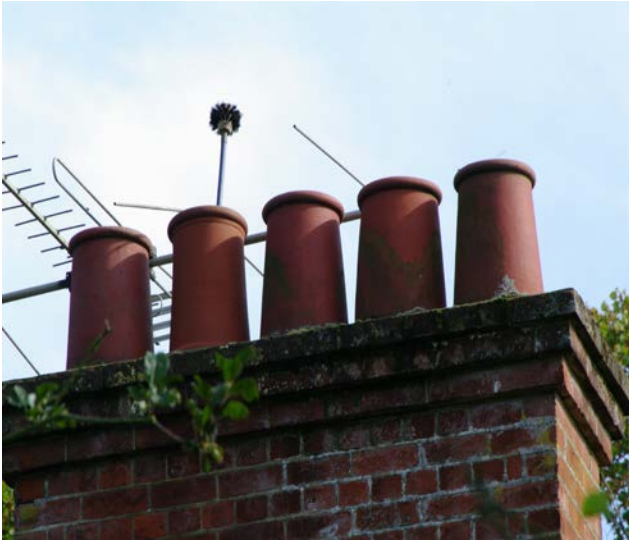
**Figure 30:** Chimney sweeping. Photo: © Douglas D Kent

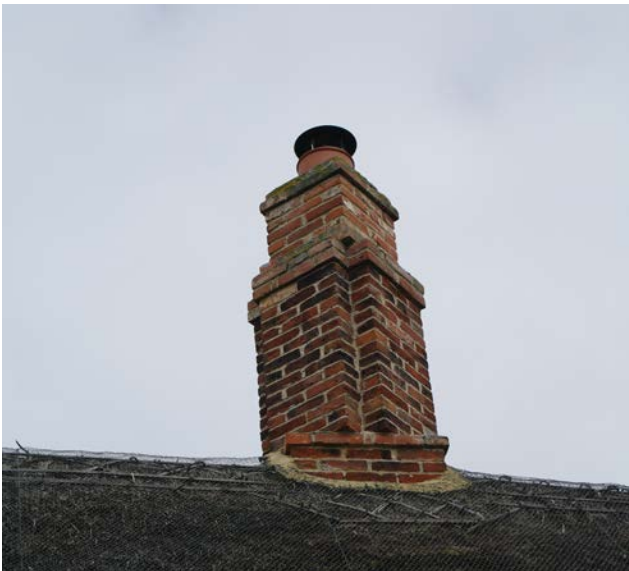
**Figure 31:** Chimney height raised on thatched cottage. Photo: © Douglas D Kent

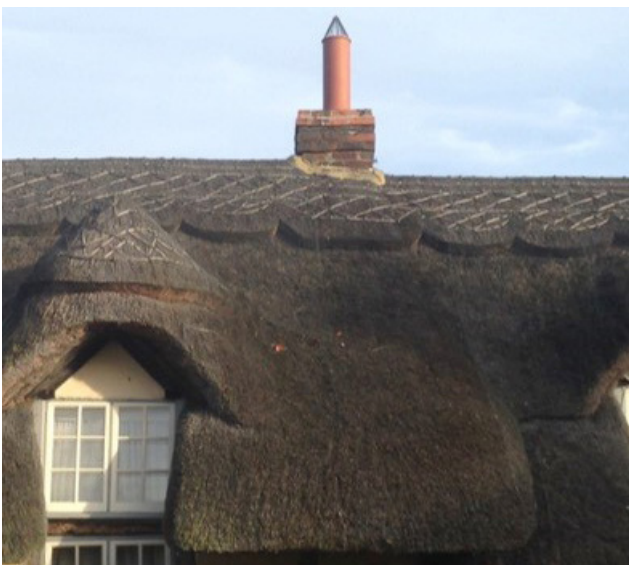
**Figure 32:** A chimney terminating less than the recommended 1.8 m above the ridge of a thatched building. The top of the terminal with an uninsulated pot is taken as being 150 mm above its base. The addition of a bird guard will reduce fire risk. Photo: Marianne Sühr

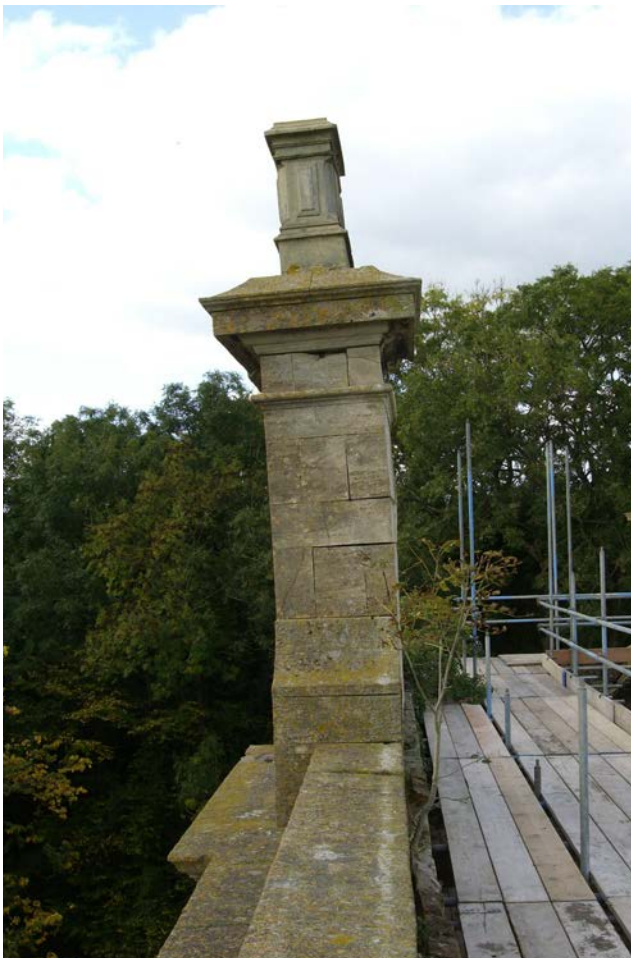
**Figure 33:** Structural instability. Photo: © Douglas D Kent

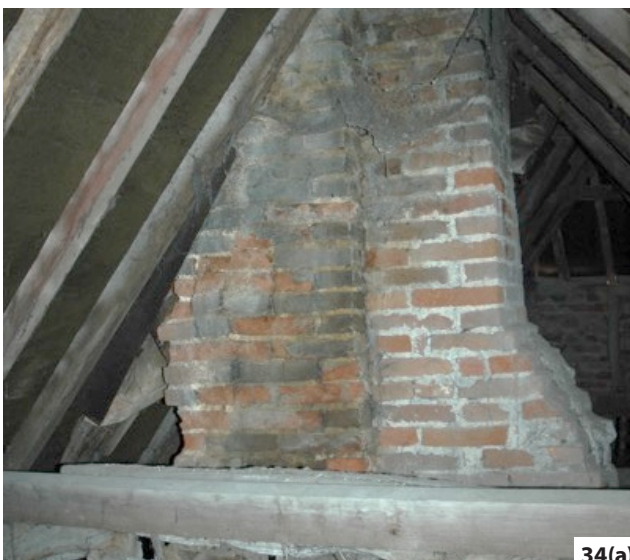
**Figure 34:** A 17th-century stack viewed from the roof space (a). Note the erosion of the brickwork just below the roofline, causing the stack to become structurally unstable. (b) The same stack was repaired by a highly skilled bricklayer who propped it, opened up the roof and replaced the damaged bricks one by one. Photo: Marianne Sühr

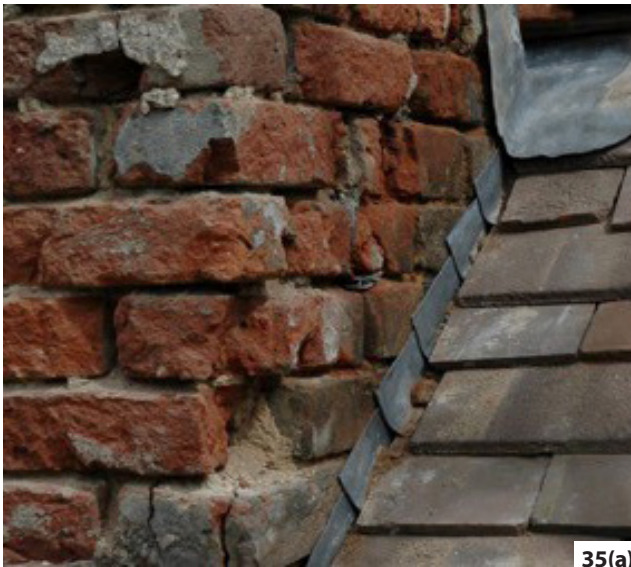
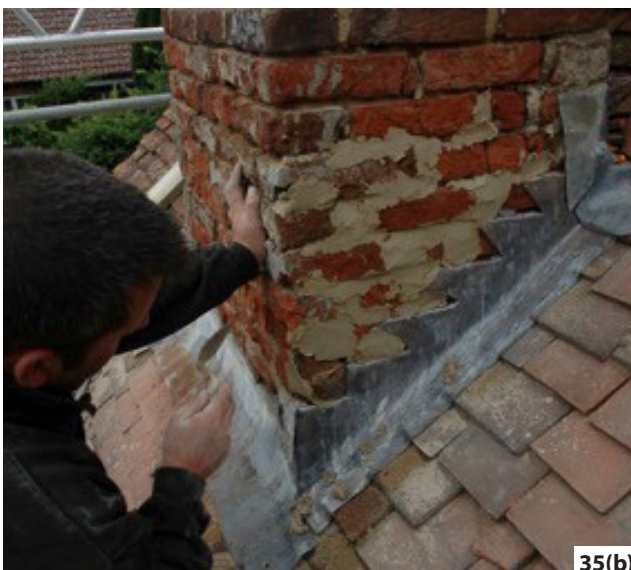
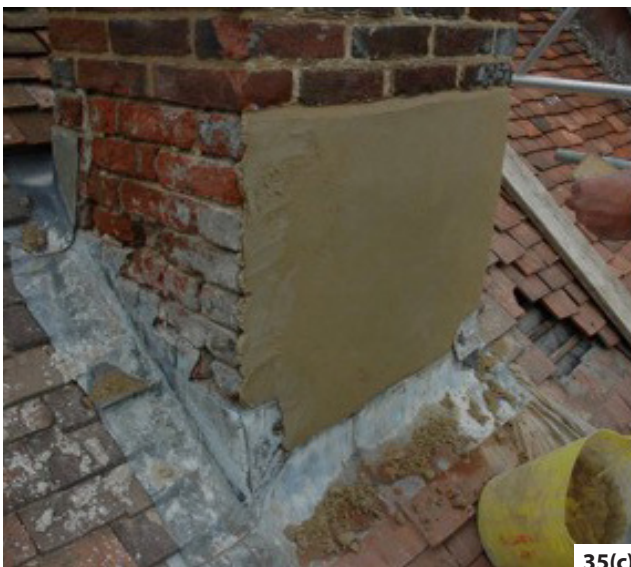
**Figure 35:** The repair of a damp chimney stack that had been coated in cement render: (a) After removing the render, new lead 'soakers' were inserted to prevent rain entering at the junction between roof and stack. (b) A continuous lead flashing was fixed to the brickwork, set into the lime mortar joints. (c) Finally the damaged brick was rendered with a lime mix. Photo: Marianne Sühr

- Use on chimney stacks of inappropriate materials, such as cement mortars and renders (see figure 35).
- Disuse of chimneys, so that open flues and hot flue gases no longer help to keep them dry, for example, from moisture penetrating due to lack of damp-proof courses.

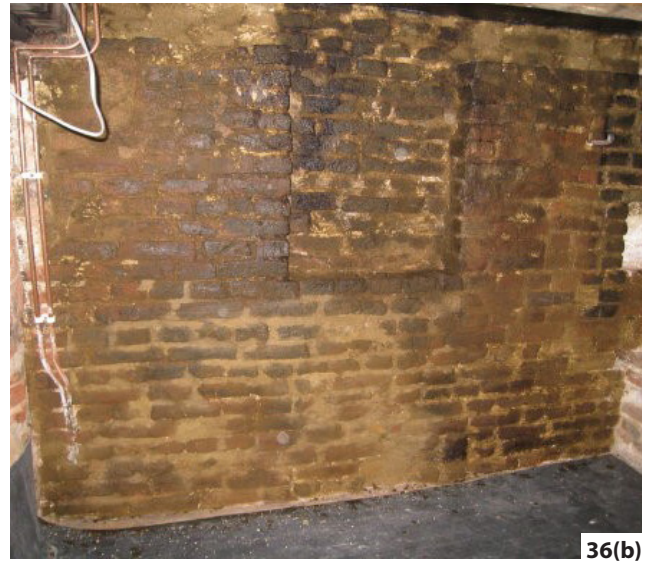
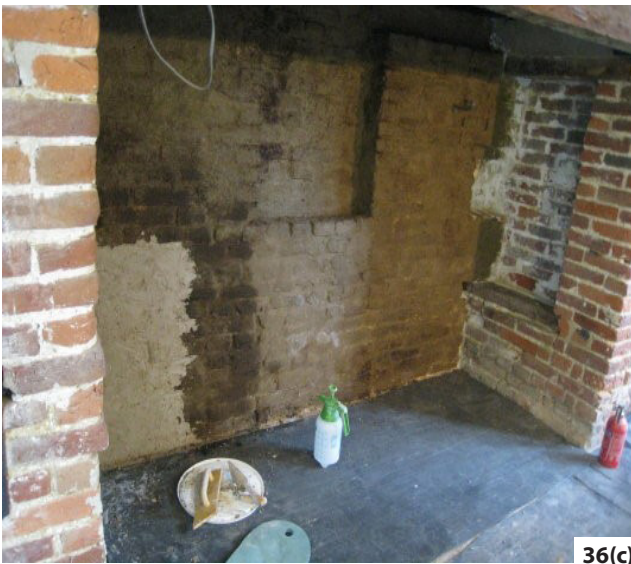
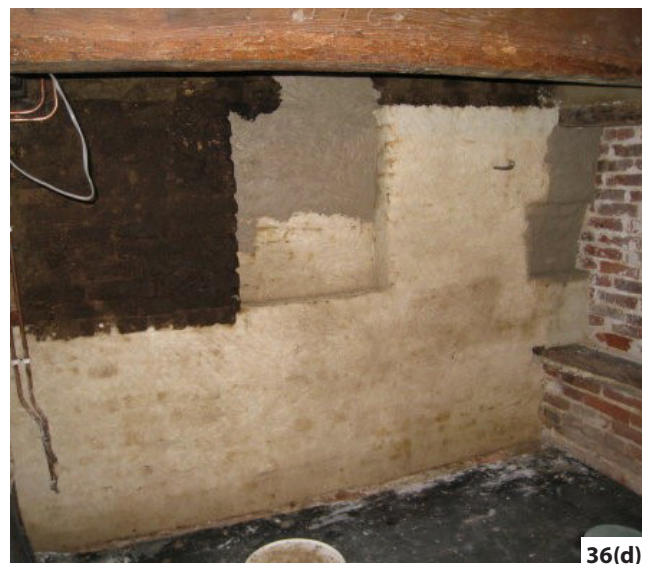
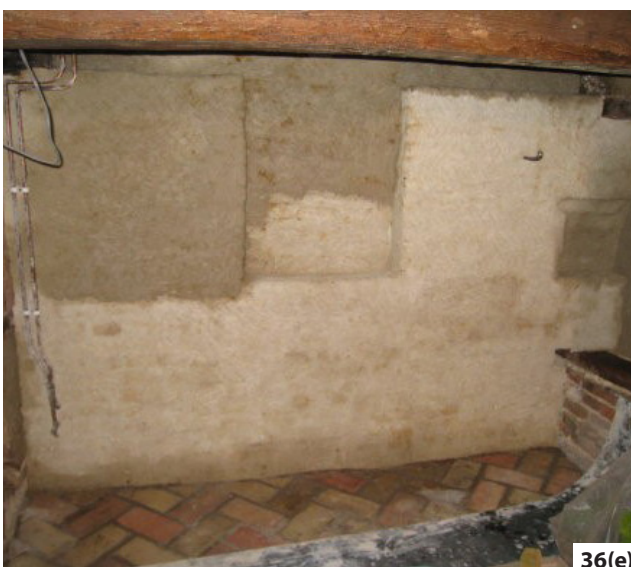
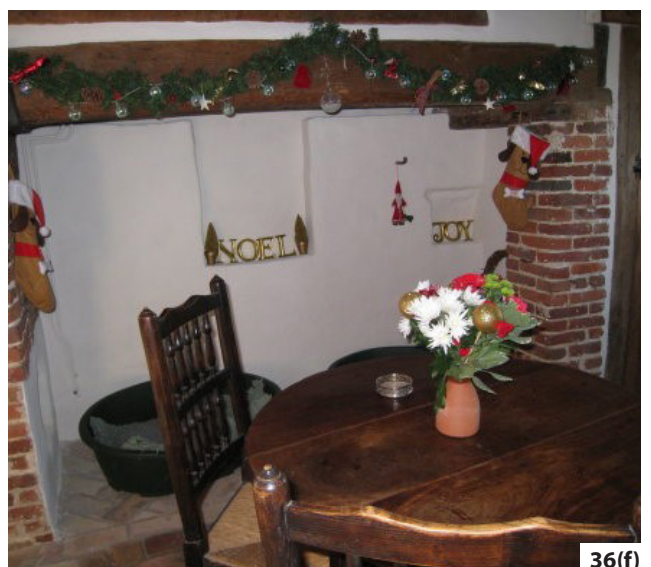
**Figure 36:** Using cow dung to prevent tar leaching in old chimneys: **(a)** Tar on bricks. **(b)** Two coats of fresh cow dung diluted to the consistency of ice cream are brushed on first, allowing thorough drying between them. **(c)** Manure is mixed into a scratch coat in a ratio of 3:9:1 lime: sand: manure. **(d)** The surface is worked, any cracks trowelled up with a wooden float as they appear and a key scratched when the coat is green hard. **(e)** A second lime coat and lime skin are applied as normal. **(f)** Finished inglenook with breathable paint.  
 Photos: © Yvonne Reynoldson

If stained plaster is renewed, a slurry of cow dung applied to the affected masonry prior to lime plastering often stops further staining, as with fireplace recesses (see figure 36). Alternatively, the new plaster can be separated from the masonry on chimney breasts using laths. These measures assume that the issues with dampness and tracking moisture have been addressed.

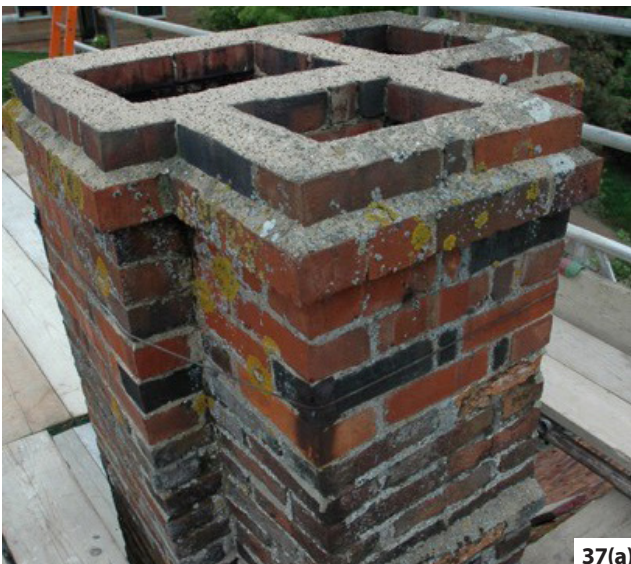
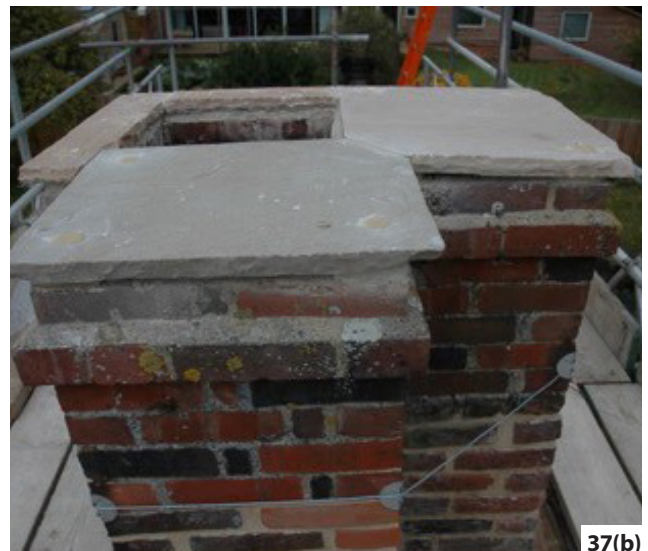
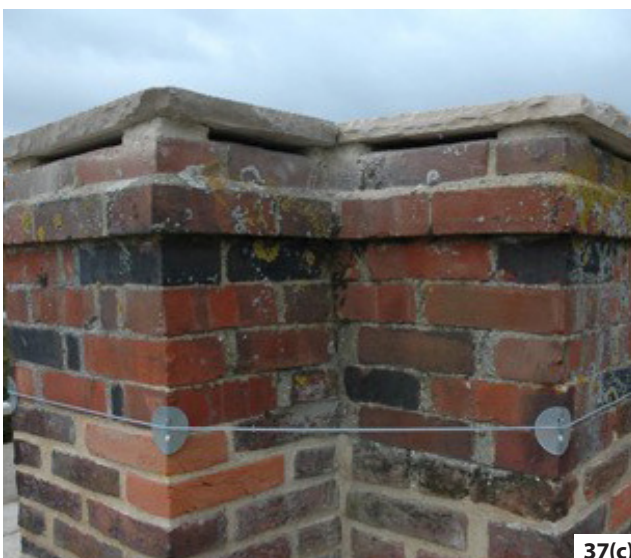
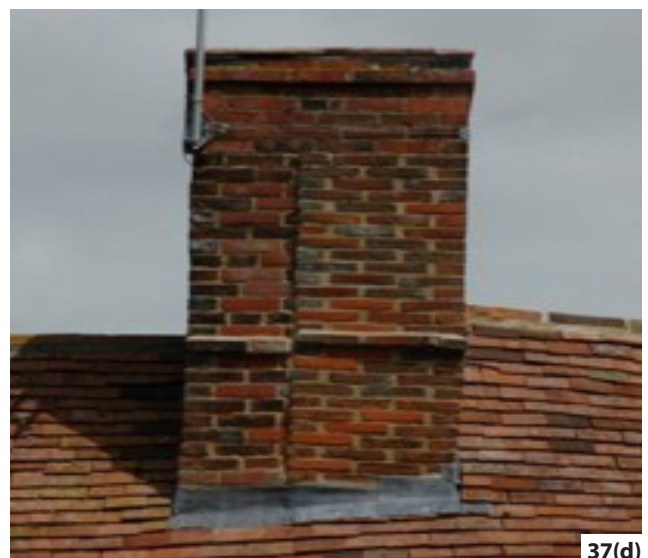
**Figure 37:** Chimney termination: (a) The stack shown in figure 34 from above. Note the exposure to the weather and previous attempts at repair using cement-based mortars. (b) The top of the stack protected with new stone slabs. The two redundant flues have complete slabs, the working flue has a stone capping to the brickwork. (c) The redundant flues have air slots to prevent condensation. (d) The finished stack, repaired using hydraulic lime mortar.

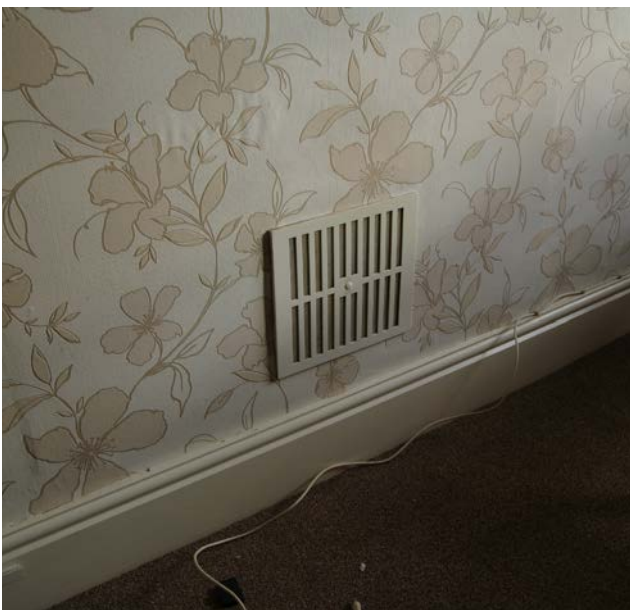
**Figure 38:** A redundant flue should be ventilated at the bottom where the fireplace opening is blocked off.
